**BOTKIN HISTORIC  
BUILDING  
CONSERVATORS**

Connaught School site plan

## Exterior Masonry Condition

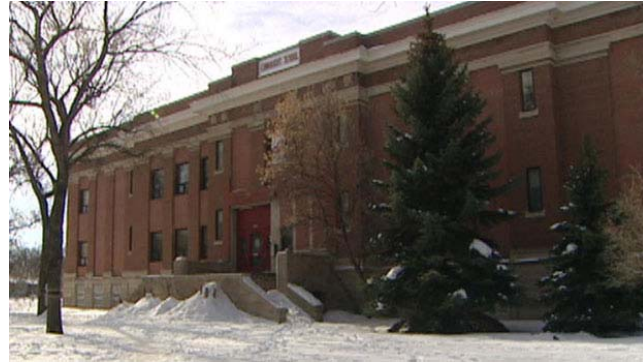
Connaught School circa 1912 and present

This was Connaught circa 1912 and as it appears today. A poor example of its former glory. Windows have been bricked over limiting the amount of sunlight and fresh air which instead is now controlled through mechanical and electrical systems. This is completely contrary to the original design of the architect who so carefully took into consideration the orientation and placement of the school. The portico over the front entrance has been removed exposing the stairway to water penetration and environmental deterioration. This shows a complete lack of understanding between design elements, form and function.

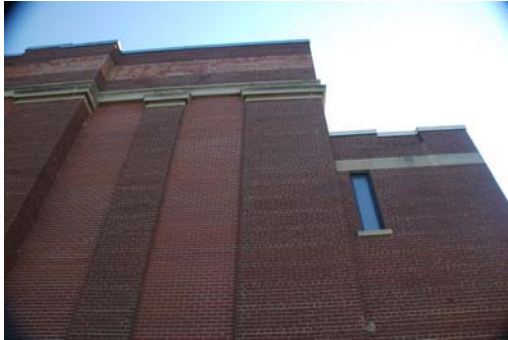
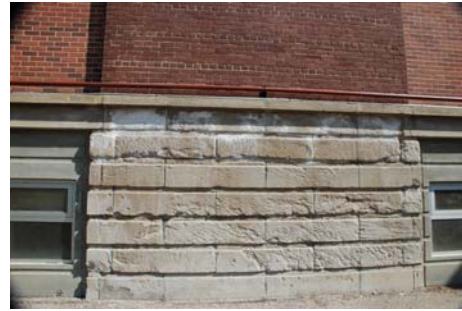
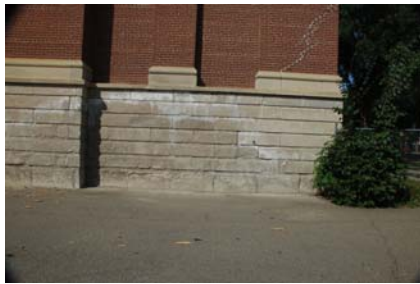
The cornice was removed for unknown reasons allowing water penetration into a soft clay brick face that was meant to be protected by the cornice. The pointing mortar in this area has deteriorated or is missing due to this exposure. The cornice could be easily reinstated and the parapet repointed. The lower limestone sections if deterioration was caused by completely inappropriate interventions. The soft Indiana Limestone was pressure washed forcing water into the porous stone which in turn caused the efflorescence present on the exterior of the building face. Also the pressure washing removed the protective patina on the stone causing spaulting . The wand marks from the pressure washing are still clearly visible. This intervention was supposedly done to remove graffiti but instead has caused substantial damage.

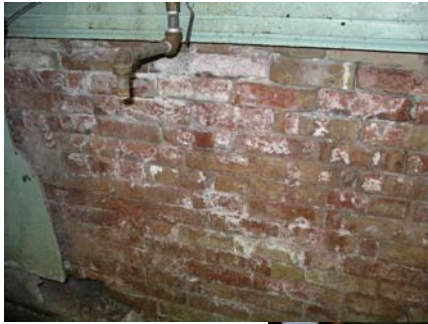
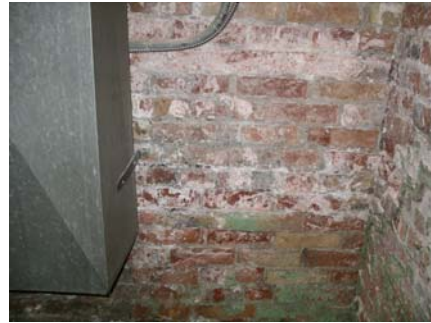
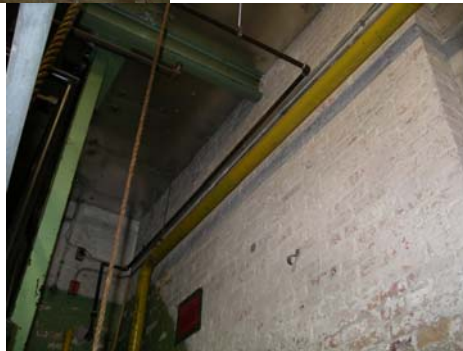
Interior Masonry Conditions

The interior masonry also shows evidence of efflorescence and in some cases spauling of the brick faces. This is caused by a few factors: 1) there is asphalt and concrete placed directly against the face of the building. This causes water to wick through these materials and into the more porous brick and limestone. This causes a condition called rising damp which means that water continues to travel through the porous materials, saturating the building envelop and appearing on the exterior as a white powdery substance. 2) I am guessing that the weeping tile system around the perimeter of the building has collapsed and is impacting moisture saturation and the movement observed around the building. 3) A portland mortar was used to selectively repoint the brick. Since this is a substantially stronger material than the soft brick, the brick has spaulted leaving piles on brick material at the base of the wall.

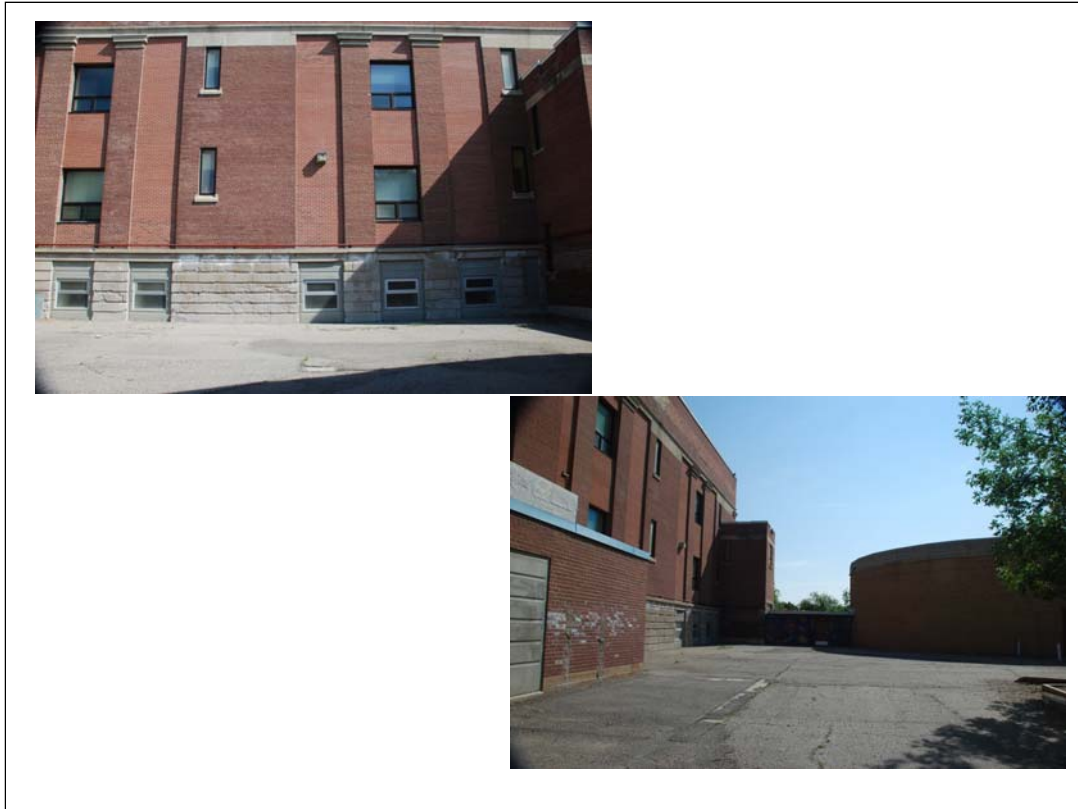
Concrete and asphalt placed directly against the exterior walls.

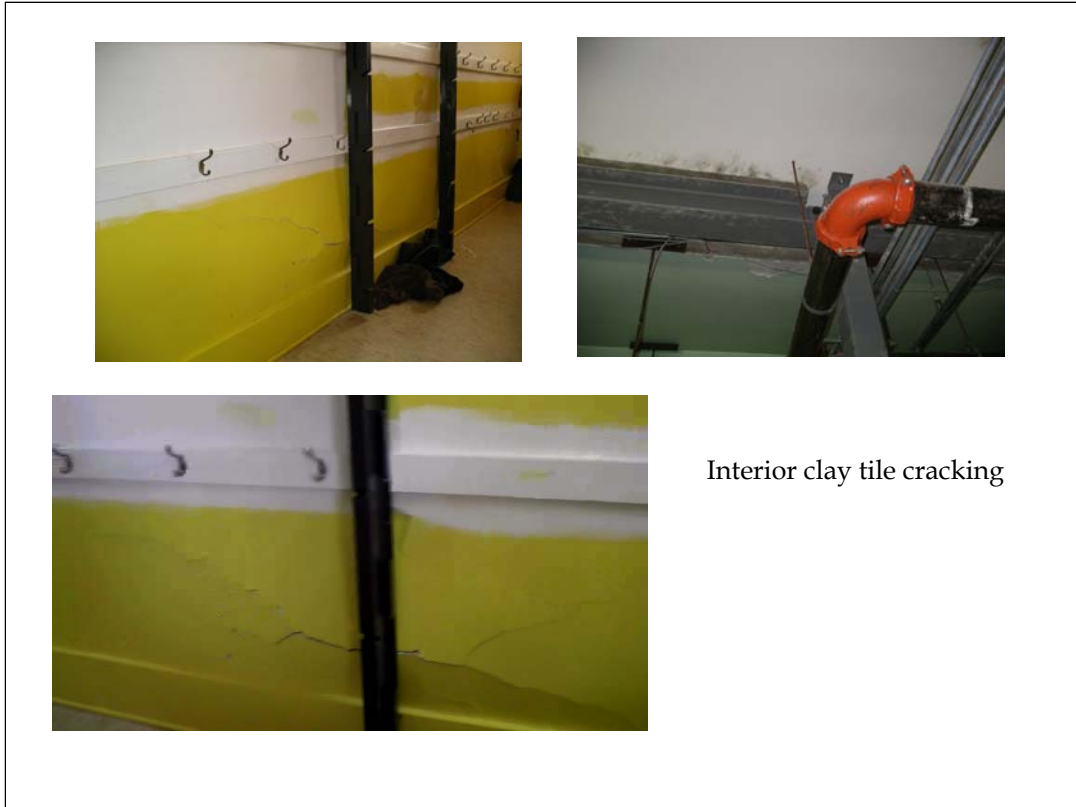
This is an example of good intentions gone wrong. This is the cloakroom in classroom 12. A rigid structural steel support system was installed in the basement directly below this area to prevent a sag in the floor. What you are seeing in these pictures are the pressure of the steel pushing up on the clay tile wall system basically crushing it. The wall is non structural according to the historical drawings and has a 24 inch space between it and the wall of the adjacent classroom. The cracking in this area was noted in the November 2012 structural engineers report where remedial work was recommended but not carried out. Then in December 2013 the room was evacuated due to the serious deterioration of the wall so that emergency repairs could be undertaken.

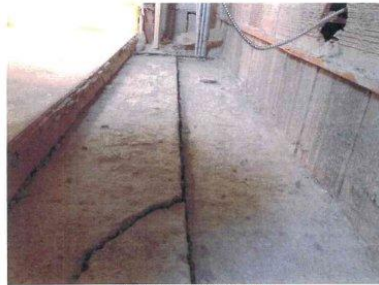
Photo 25: Floor Crack at Room 12

The non-structural clay tile wall has been removed from the cloakroom which revealed deflection between the floor slabs in this area. The problem is that since the structural steel framework directly below this area is not adjustable the damage and deflection to the floors and walls will continue. This is another example of an intervention that has caused damage and deterioration.

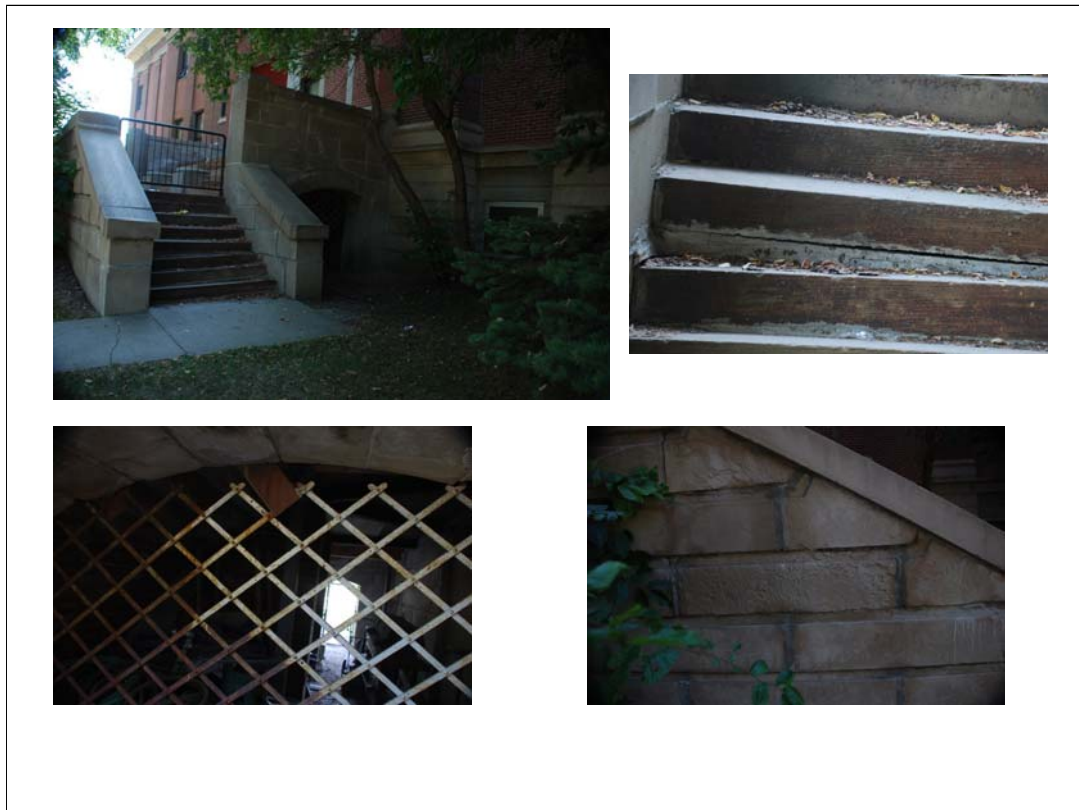
These are photos of the front staircase with sagging **treads**. They also show completely inappropriate interventions to repair the situation. A portland based mortar was used to fill and repair the spaces between the treads and risers and also as a pointing mortar on the stair parapets which has caused efflorescence, spauling of the stone and general deterioration. Supporting the staircase is a brick pier system. It is my understanding that there was a broken water tap in this area that was not repaired for years. The water penetration and saturation of the soil would then cause the support system to sink causing the movement evident in the area.
