Facility Audit Report

Connaught

Facility Audit report for: Connaught
Regina, SK
Report Created: 2012-04-02

The structural Facility Audit of Connaught School was conducted in April and May, 2010 by Holly Sawka and Nathan Campbell, J.C. Kenyon Engineering Inc.

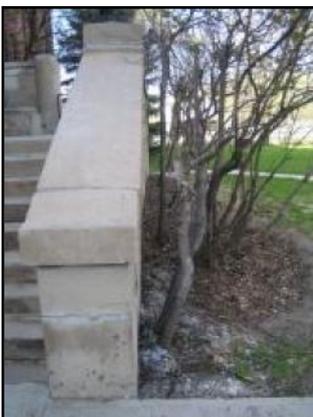
Photograph 002.jpg

The foundation of the front entrance and stairs has also experience significant movement which has caused the stairs to sink, shift, and for the arch to separate, see photographs 1, 2, and 3 below.

Rectification of the problem of foundation movement would be to underpin the entire building. Proper drainage away from the building should also be ensured.

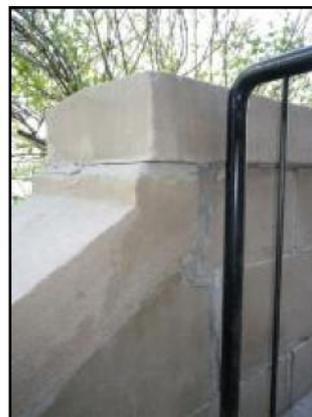
Photograph 005.JPG

There has been significant movement of the foundation which has caused the building to shift resulting in various problems such as cracking of beams, slabs, and walls.

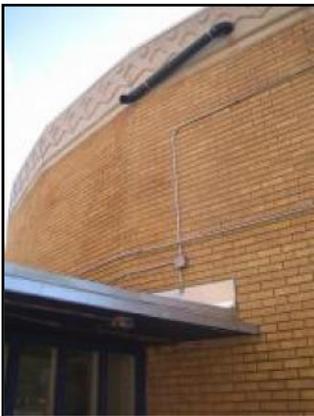
Photograph 002.jpg

The drain spouts on the exterior of the building are not directed away from the building, see photographs 1 and 2 below.

If drain spouts are not directed away from the building water will run down the building and could potentially seep into the foundation which can cause damage or movement of the foundation.

Drainage spouts should be redirected so that they drain away from the building.

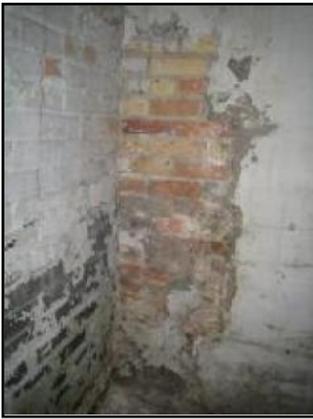
Photograph 002.jpg

All of the brick walls in the basement that are not covered in finishes are badly deteriorated, especially walls that are below grade. Deterioration of the walls can be seen below in photographs 1, 2, and 3 which are all pictures of the west exterior wall. The exterior walls on the east side are mostly covered in finishes and therefore could not be inspected. On the west exterior wall of the boiler room the brick has deteriorated to the point that there is a hole through the wall, see photograph 4 below. This also occurs in the room north of the machinery room, see photograph 5 below. This deterioration of the exterior brick walls is most likely due to continual saturation of the brick from moisture in the surrounding soil. The grout in the North machinery wall has deteriorated and is coming apart like chalk, see photograph 6 below. The interior load bearing brick walls in the boiler room have various cracks in them and should be re-pointed, see photographs 7 and 8 below. There is also cracking in the interior brick wall where it supports a concrete beam in the mechanical room, see photograph 9 below.

Walls should be excavated and fixed, which would include a new vapour barrier, insulation, weeping tiles, and the repair of the bricks. Brick walls should be re-pointed and the holes in the wall should be fixed.

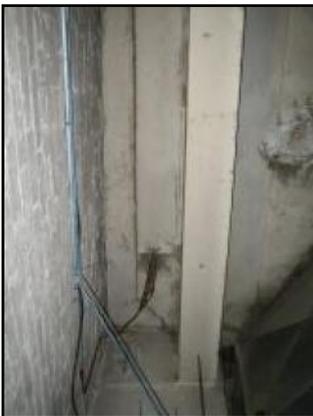
Photograph 002.jpg

There is a large jagged crack in the bottom of the main floor slab which can be seen from below in Room 2, see photograph 1 below. The crack is parallel with the floor beams and occurs between two closely spaced beams which both support partition walls above. The space above the crack was inaccessible and is believed to be a space for running duct work. This crack may have resulted due to foundation movement. According to the drawings there are three other similar locations where two beams running parallel to each other are closely spaced. Two of the locations were inaccessible and could not be inspected from below or from above, and the third occurs on the north side of the machinery room. At this location there is a straight cracking or separation in the floor slab running parallel to the two beams which can be seen below the slab, see photographs 2 and 3.

Reinforcement of the slabs and beams. Replacement of the floor slab is not feasible.

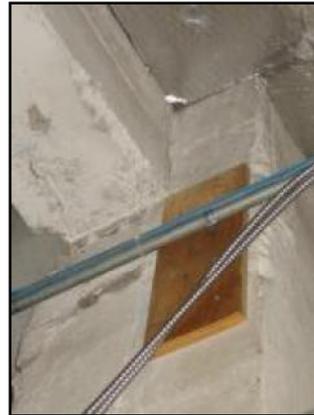
Photograph 009.jpg

Most of the floor beams were concealed in plaster finishes. Some of the beams covered in plaster finish had small cracks in them, see photograph 8. In the boiler room the beams were not covered and could be properly inspected. The south beam running east and west had cracks on the east side where it connected with the column, and cracking on the column beneath the beam, see photograph 9 below. The slab beam which supports the beams running east and west had various cracks in it. In photographs 10 and 11 below, cracks on both ends where it connects with the masonry wall can be seen. In photograph 12 below, a crack where it connects to the beam running east and west can be seen, and in photograph 13 below longitudinal cracks can be seen in the slab beam. In photograph 14 below, a crack on the underside of the beam can be seen where the beam running east and west connects to it.

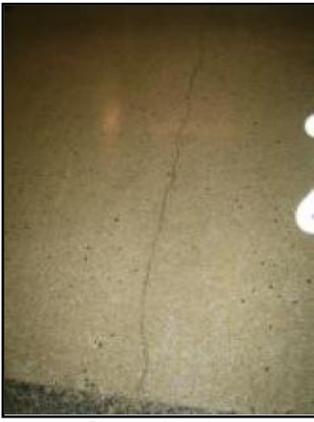
Photograph 003.jpg

On the first floor, there are various cracks in the finishes at the top of the floor slab in the hallway, mostly occurring where the slab joins with the floor beams near the end of the beams, see photographs 1, 2, and 3 below. Similarly to the main floor, the first floor slab has a significant sag in various areas, especially in the middle of most classrooms.

Reinforcement of the slabs and beams. Replacement of the floor slab is not feasible.

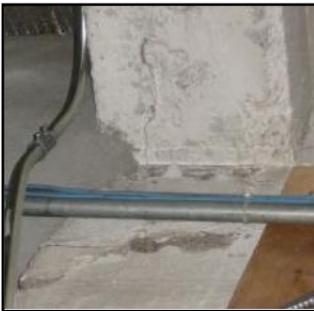
Photograph 002.jpg

With the exception of the concrete columns in the Boiler and Mechanical room and the columns in the penthouse on the roof of the building, most columns are covered in finishes. Spalling of the concrete at the base of the columns in the boiler room can be seen in photograph 1 below. There is also cracking at the top of the South column in the Boiler room just below the connection to a concrete beam, see photograph 2 and 3 below. In the penthouse on the roof there is cracking at the top of the columns, see photograph 4 below.

Cracking in columns should be fixed.

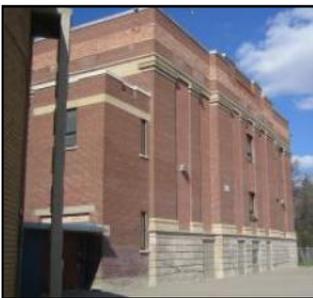
Photograph 004.jpg

The exterior masonry walls have been repointed many times in the past which can be seen in various locations, such as the crack in the corner of the South East side, see photograph 5 below. Many cracks have developed in the walls due to shifting of the foundation. There are still several locations that need to be repointed, see photographs 7 and 8 below. The stone at the base of the building has significantly deteriorated. In various locations the mortar between the stone blocks has completely deteriorated, see photographs 9 and 10.

The deteriorated or cracked mortar joints in the exterior wall should be re-pointed. This should be done on an annual basis to maintain the integrity of the wall structure. A penetrating sealant should be applied to the stone at the base of the building to prevent further deterioration. The cornice in the front of the building should be repainted. Where the cornice was removed, the bricks should be re-finished or covered.

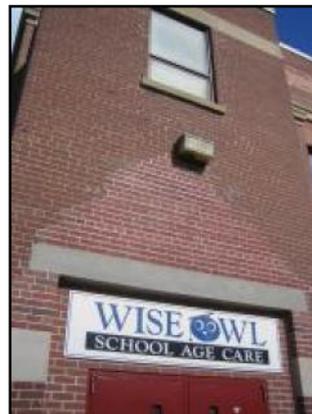
Photograph 006.jpg

The exterior walls of this building consist of multiple withes of brick and are load bearing walls. Photograph 1 below is the front or East side of the building, photograph 2 is the West side of the building, photograph 3 is the North side and photograph 4 is the South side. With the exception of the front of the building, the wood cornice located at the top of the wall has been removed. Many of the windows have been filled in with brick in the past. It also looks like the lintels above the doorways on the west side of the building were replaced at one point, see photograph 6.

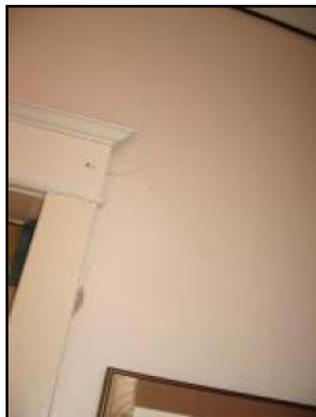
Photograph 001.JPG

There are various cracks in the partition walls throughout the building, see photograph 1 below. Where a partition wall was removed in the room just north of the machinery room, the floor above, Room 12, is badly deflected. The underside of the slab where the wall was removed also shows signs of distress and the wall above the wall that was taken out has experienced significant cracking, see photographs 2 and 3, below. It is most likely that the removed partition wall was acting as a load bearing wall.

The partition wall that was removed was likely acting as a load bearing wall, as it was removed the slab above is now supporting the tile wall above and shows signs of being overloaded. This should be immediately fixed by bracing the slab where the wall used to be in order to relieve the load off of the slab. Cracks in the partition walls should also be fixed.

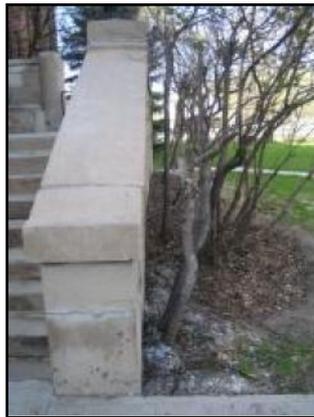
Photograph 003.jpg

The exterior stairs at the front entrance has experience significant movement and deterioration. The stairs should be monitored. The movement of the stair has caused the staircase to sink on the east side, see photograph 2. In photograph 3, it can be seen that the staircase has bowed out. Photographs 4 and 5 show how the arch has separated in the past which was most likely due to movement of the foundation in the past. Photograph 6 shows how the blocks have shifted. It should also be noted that the mortar holding the blocks together has completely deteriorated in various locations.

Deteriorated mortar should be replaced and the stairs should be fixed. Due to the significant movement of the stairs, it should be closely monitored in the future.
