Facility Audit Report

Wascana School

Facility Audit report for: Wascana School

Report Created: 2014-05-05

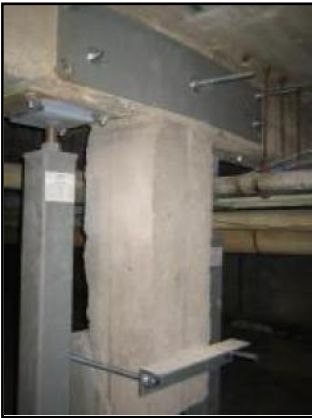
Photograph 004.jpg

This building has experienced considerable differential movement of the foundation, especially in the south wing of the building. Deterioration and damage to this building in terms of cracks in walls, columns, beams, and slabs as well as heaving of slabs has been caused by differential movement of the foundation. Differential movement is caused by settlement of the footings as the soil dries, or heaving of the foundation as the soil expands due to an increase in moisture.

The south wing of this school has experienced considerable differential movement, especially the south east corner which has noticeably dropped. This movement is believed to be caused by a decrease of moisture in the soil in the south crawl space. The footings in the south crawl space are settling which is causing increased stress on the concrete columns, slabs, and beams above the footings. In one location in the south crawlspace, a column has already failed due to the increased stress, photograph 004 and 005. This column has been fixed but there is still the risk for similar events to occur in the future. As mentioned in the main floor section, there are hairline cracks in the beams, slabs, and columns, in the main floor structure which can be seen in the crawl space below.

Rectification of the problem of foundation movement would be to underpin the entire building which is an expensive process.

Without major structural upgrades to this foundation, it is not suitable for long term occupancy. As it is our understanding that this school only has a one year lifespan left and is scheduled to be closed in 2013, our recommendation is that the foundation beneath the south wing of the school be monitored for changes with ongoing inspections occurring ever six months. As previously mentioned in the last report, proper drainage away from the building should also be ensured in order to help prevent movement of the foundation.

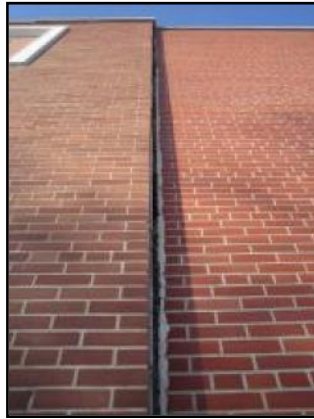
Photograph 030.jpg

The expansion joint between the original building and 1958 addition has opened up to form a gap. The gap is approximates 1 1/2 inches.

The original 1951 part of this building has a footing foundation while the 1958 addition of this building has a pile system foundation. The different foundations have resulted in differential movement as there is less foundation movement in the deep, pile system than in the shallower footing system.

The separation gap should be repaired. Underpinning of the entire original building would reduce future movement.

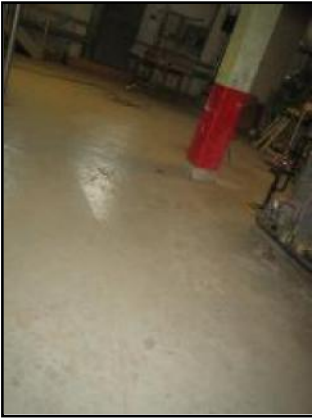
Photograph 006.jpg

Excessive heaving and settlement has caused unevenness of the floor throughout the entire basement. In general, the floor seems to be heaved upwards at the center of the class rooms and corridors, while the slab in the boiler room has settled and cracked at column locations. The settlement of the slab at columns is an indication that the footings in the boiler room have settled at some point in the past, photograph 006.

The extensive heaving of the floor slab could be fixed by the replacement of the existing floor slabs with structural slabs however this would be an expensive procedure.

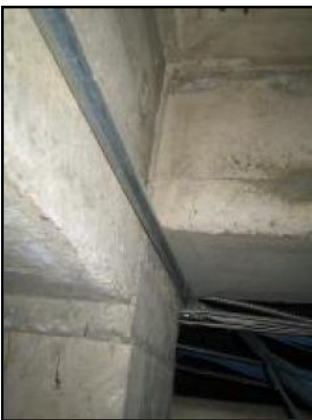
Photograph 016.jpg

When inspecting the south crawlspace, which is below the main floor of the south wing, cracks in the floor beams and slabs as well as the columns were noted in various locations, especially the south east corner of the building, photograph 016 and 017. Exposed rebar was noted in two different floor beams, photographs 011 and 012. Deflection of the floor beams can be seen in photograph 010.

It is believed that the foundation movement caused by settling of the footing is causing the slope to the main floor as well as the cracking of the beams and slabs on the underside of the floor.

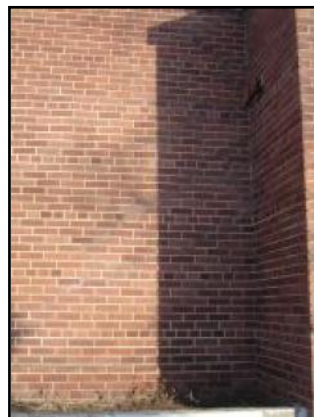
Photograph 043.jpg

The exterior walls have been re-pointed in the past which can be seen in photographs 038, 040, and 043. Cracks have continued to develop in the brick veneer and concrete foundation wall on the south and east side of the building, which is due to shifting of the foundation, photographs 034, 035, 042, 046, 048, 051 and 045. Deterioration can also be seen in the exterior finishes, photographs 022, 023, and 024. Exterior walls should be re-pointed to repair cracks and mortar deterioration.

Cracks and mortar deterioration in the exterior walls should be re-pointed. This should be done on an annual basis to maintain the integrity of the wall structure.

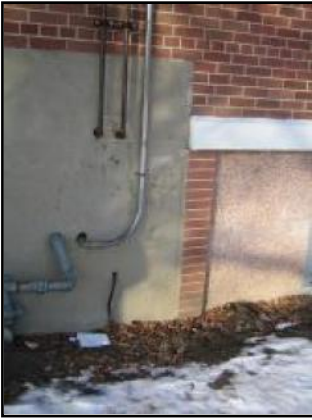
Photograph 034.jpg

Cracking is localized on the south-east corner of the building. This area seems to have experienced and continues to experience foundation shifting.

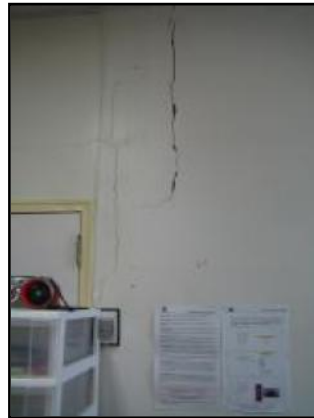
Photograph 059.jpg

There are various cracks in the drywall partition walls throughout the building. Cracks are likely caused by foundation movement.

Cracks in the partition walls should be fixed.
