**BOTKIN HISTORIC  
BUILDING  
CONSERVATORS**

Connaught School site plan

## Exterior Masonry Condition

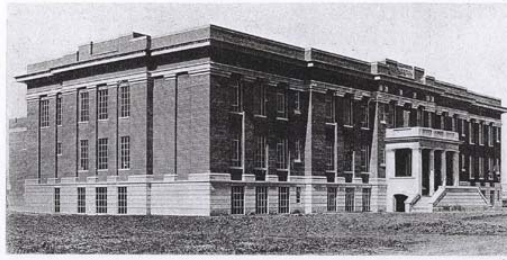
Connaught School circa 1912 and present

This was Connaught circa 1912 and as it appears today. A poor example of its former glory. Windows have been bricked over limiting the amount of sunlight and fresh air which instead is now controlled through mechanical and electrical systems. This is completely contrary to the original design of the architect who so carefully took into consideration the orientation and placement of the school. The portico over the front entrance has been removed exposing the stairway to water penetration and environmental deterioration. This shows a complete lack of understanding between design elements, form and function.
